# Manhole Inspection Summary

Manhole # S03II2023MH

Insp Date: **7/10/06 9:10 AM**

**Location** Address: **2907 FALLSTAFF RD**

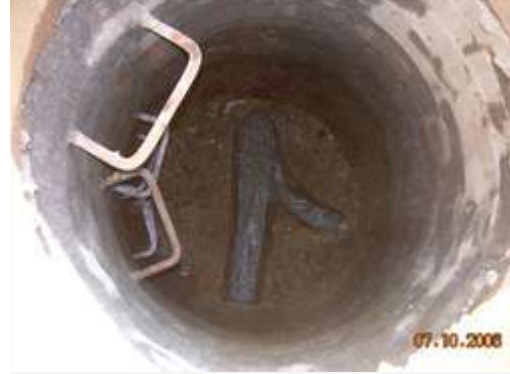
Top View

Evidence of surcharge - Bench debris.

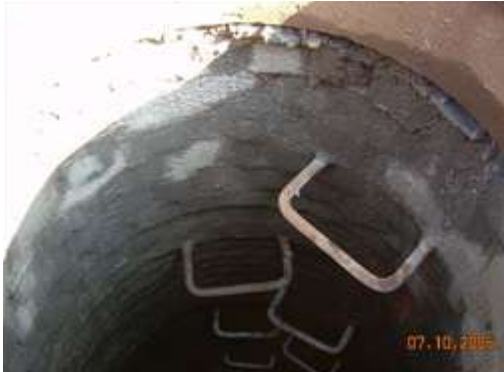
Defect

Frame leaks. Adjustment deterioration and infiltration. Corbel and Barrel infiltration.

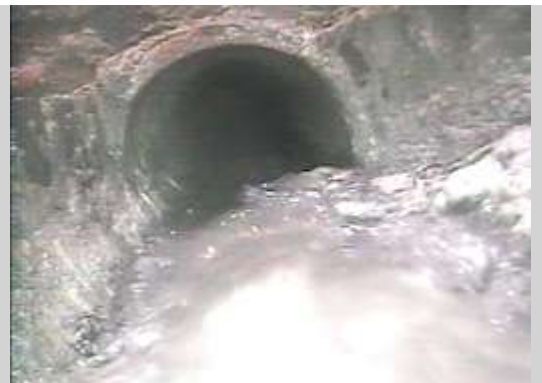
Pipe Out @ 12 O'Clock

Comments **All of the pipe pictures show grease deposits in the Channel.**

Infiltration: **Evidence** Pipe Seal Cond: **Unknown**

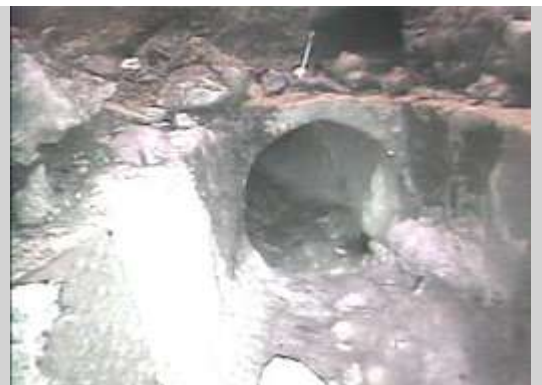
Pipe In @ 3 O'Clock

Infiltration: **None** Pipe Seal Cond: **Unknown**

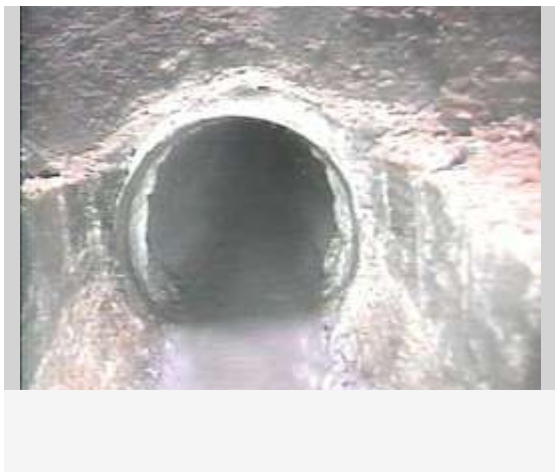
10 in. Circular Gravity Sewer  
Pipe In @ 6 O'Clock

Infiltration: **Evidence** Pipe Seal Cond: **Unknown**
